Trouble-shooting program

## 1. Rapid diagnosis chart

BMW 80 →

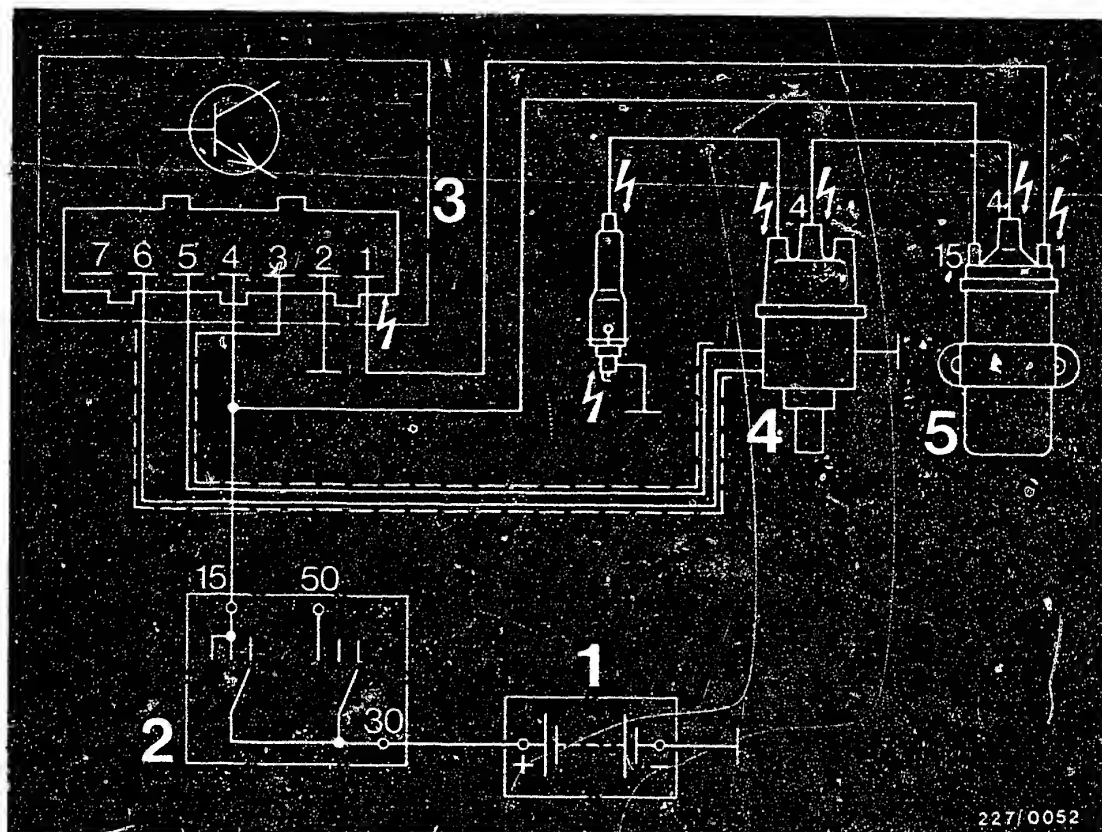
Kl. = Terminal

- 1 = Battery
- 2 = Ignition and starting switch
- 3 = Trigger box
- 4 = Ignition distributor
- 5 = Ignition coil

⚡ = Dangerous voltages (400 V - 25 kV)

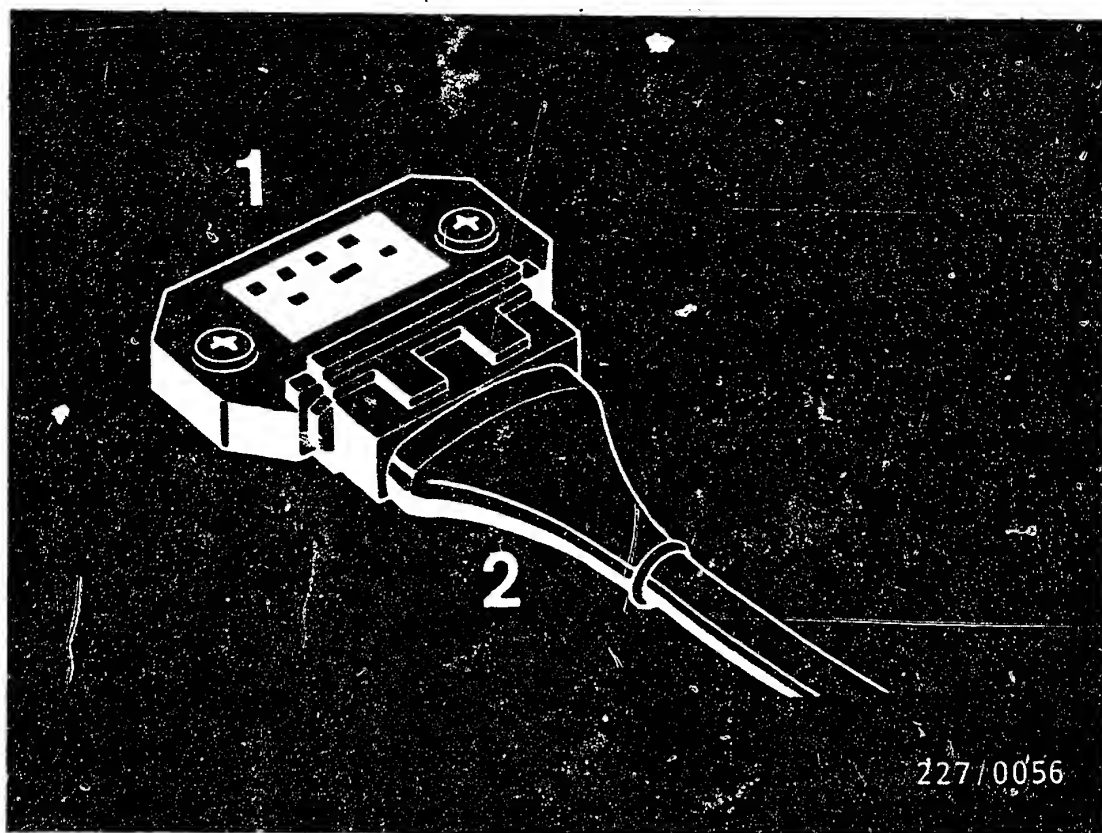
227/0056

- 1 = TI-i trigger box
- 2 = Trigger-box plug

#### 4. Installation position of components

The trigger box is mounted on a heat sink in the engine compartment.

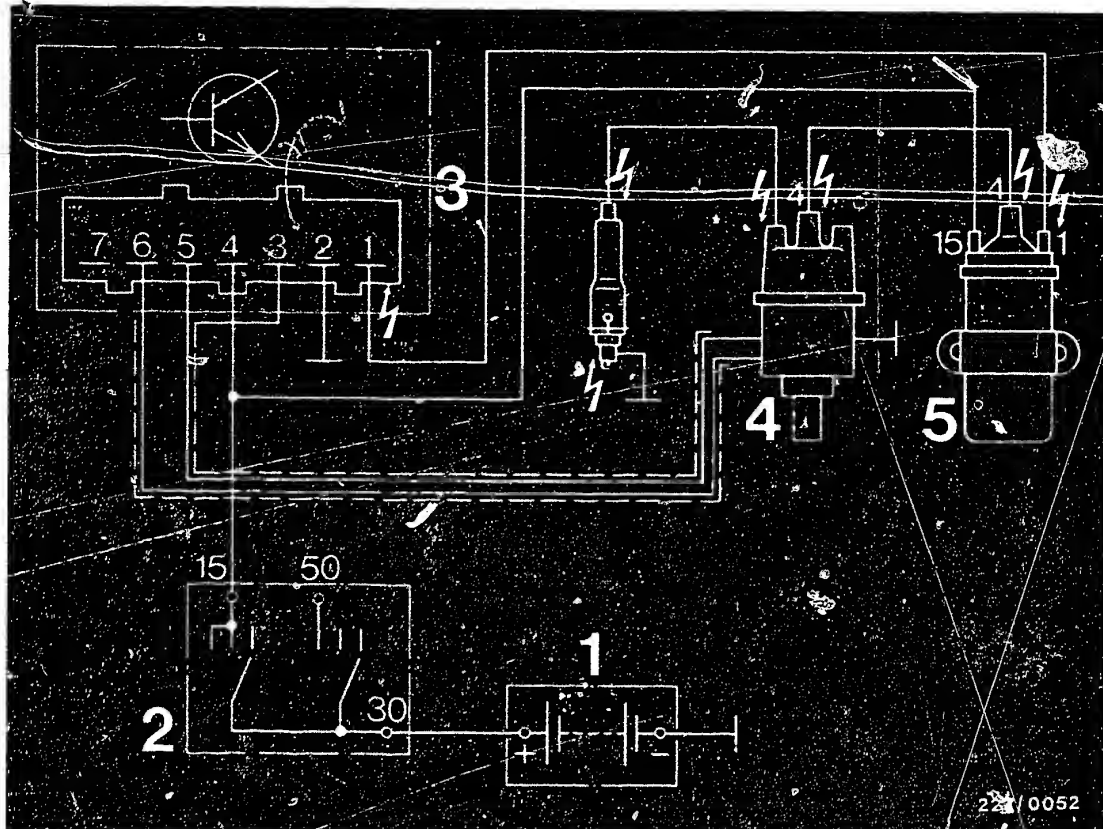
Kl. = Terminal

- 1 = Battery
- 2 = Ignition and starting switch
- 3 = Trigger box
- 4 = Ignition distributor
- 5 = Ignition coil

= Dangerous voltages (400 V - 25 kV)

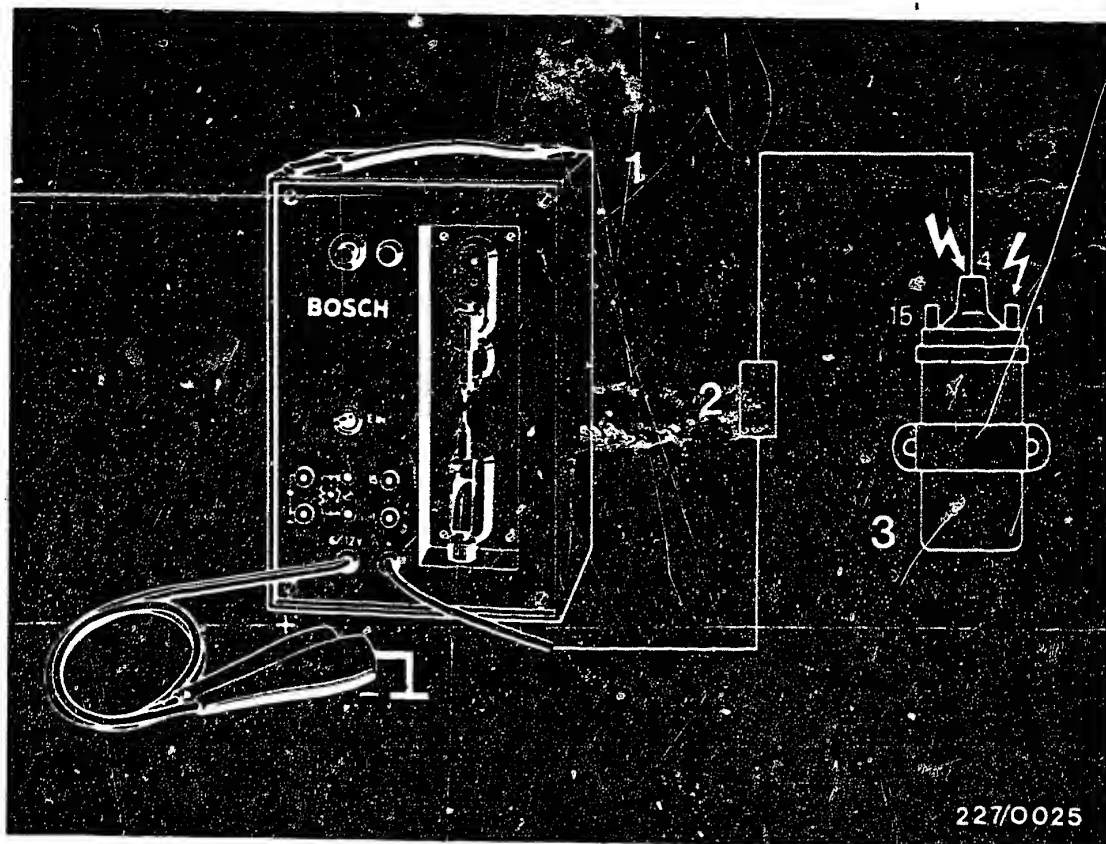
- 1 = Spark gap
- 2 = 5 k $\Omega$  sleeve-type suppressor
- 3 = Ignition coil

- In order to prevent the trigger box from being irreparably damaged, when using a spark gap, an interference-suppression resistor of at least 2 k $\Omega$  must be connected between the spark gap and ignition coil terminal 4, e.g. sleeve-type suppressor (5 k $\Omega$ ) 0 356 500 001.
- In the case of ignition distributors with engine-speed limitation the ignition distributor side terminal 4 must have 1 k $\Omega$  interference suppression. Operation without interference suppression will lead to the destruction of the trigger box.

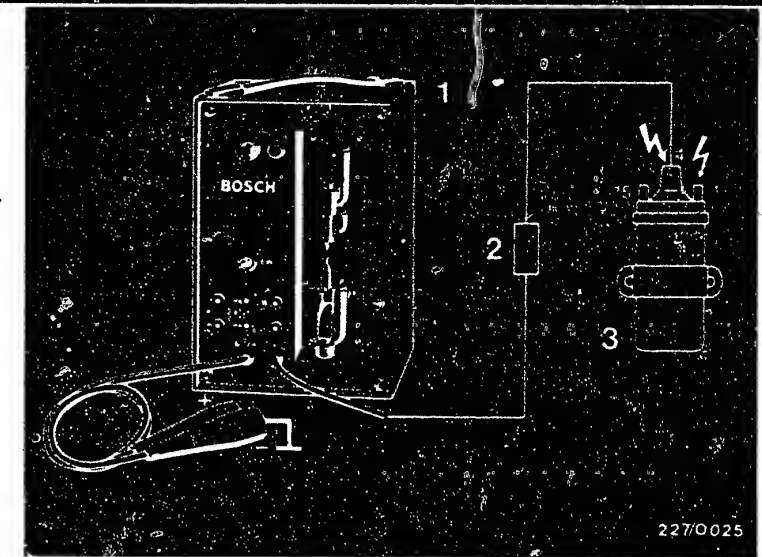
- 1 = Spark gap
- 2 =  $5\text{ k}\Omega$  sleeve-type suppressor
- 3 = Ignition coil

⚡ = Dangerous voltages (400 V-25 kV)

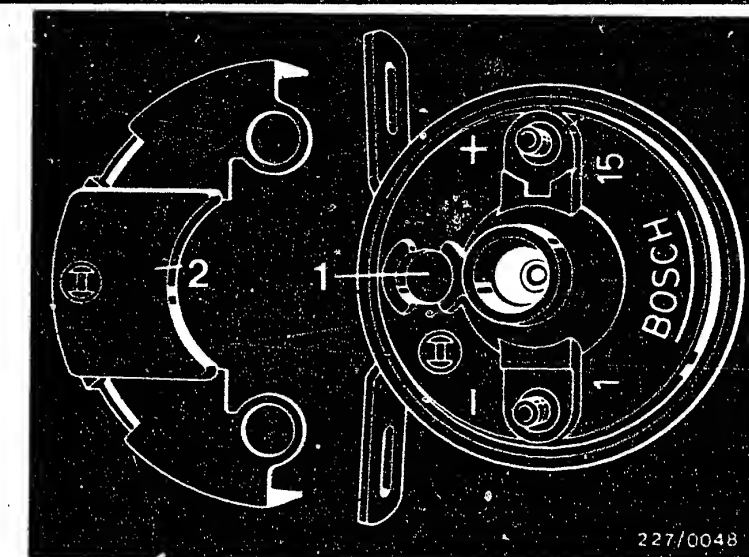
1 = Plug  
2 = Protective cap

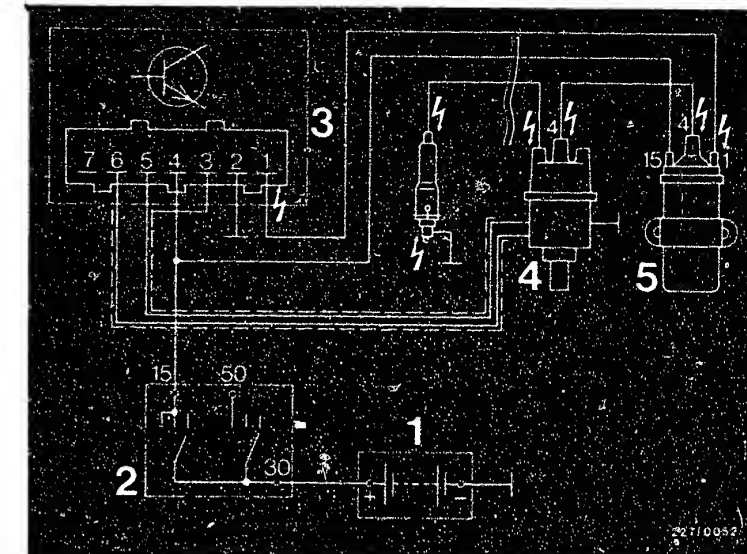
- 1 = Battery
- 2 = Ignition and starting switch
- 3 = Trigger box
- 4 = Ignition distributor
- 5 = Ignition coil

⚡ = Dangerous voltages  
(400 V - 25 kV)

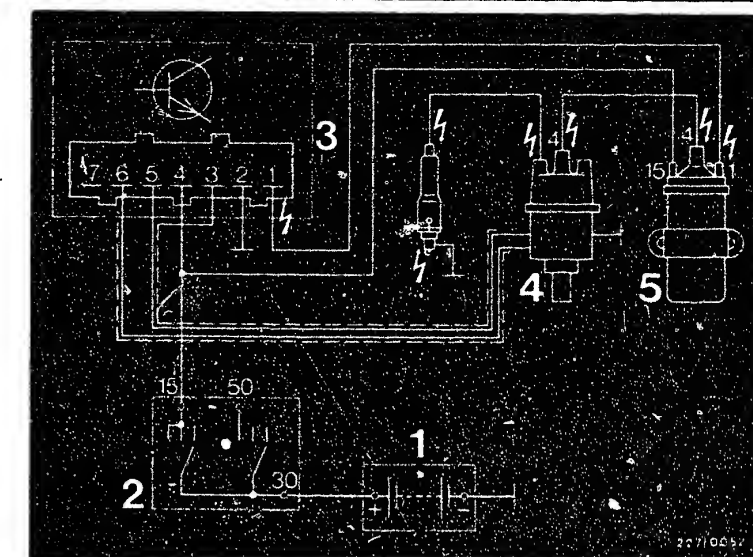
- 1 = Battery
- 2 = Ignition and starting switch
- 3 = Trigger box
- 4 = Ignition distributor
- 5 = Ignition coil

⚡ = Dangerous voltages  
(400 V - 25 kV)

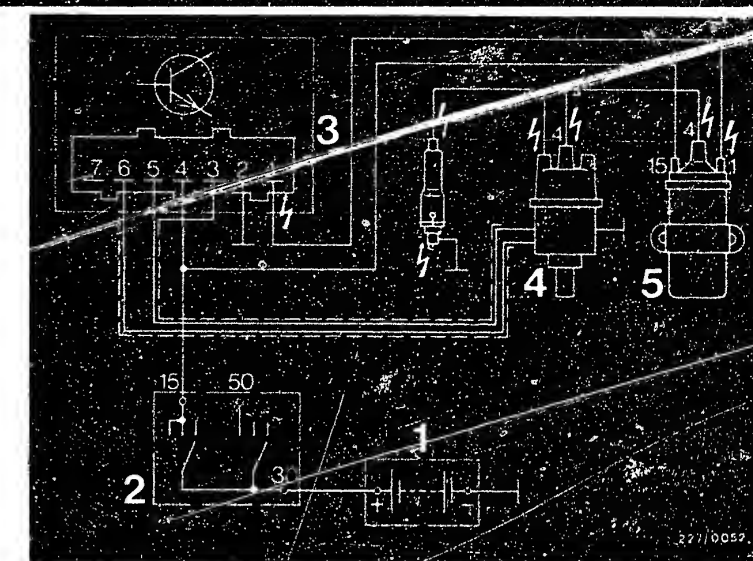
- 1 = Battery
- 2 = Ignition and starting switch
- 3 = Trigger box
- 4 = Ignition distributor
- 5 = Ignition coil

⚡ = Dangerous voltages  
(400 V ... 25 kV)

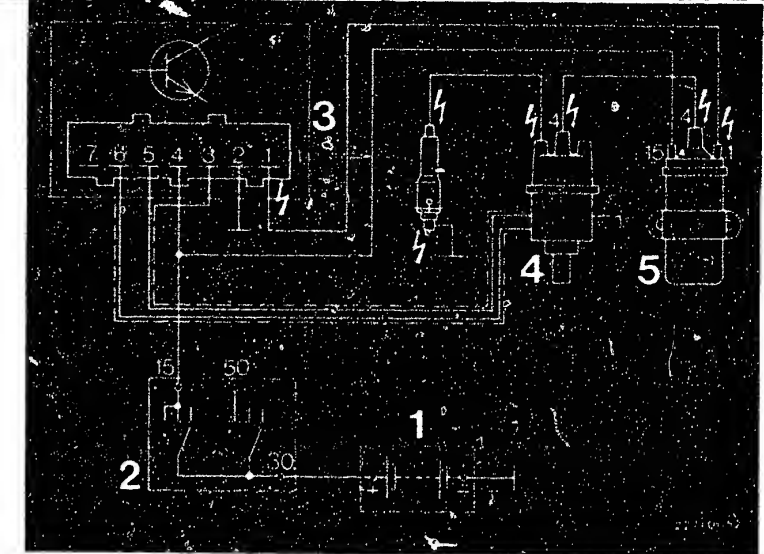
- 1 = Battery
- 2 = Ignition and starting switch
- 3 = Trigger box
- 4 = Ignition distributor
- 5 = Ignition coil

⚡ = Dangerous voltages  
(400 V ... 25 kV)

8 = Trigger-box plug

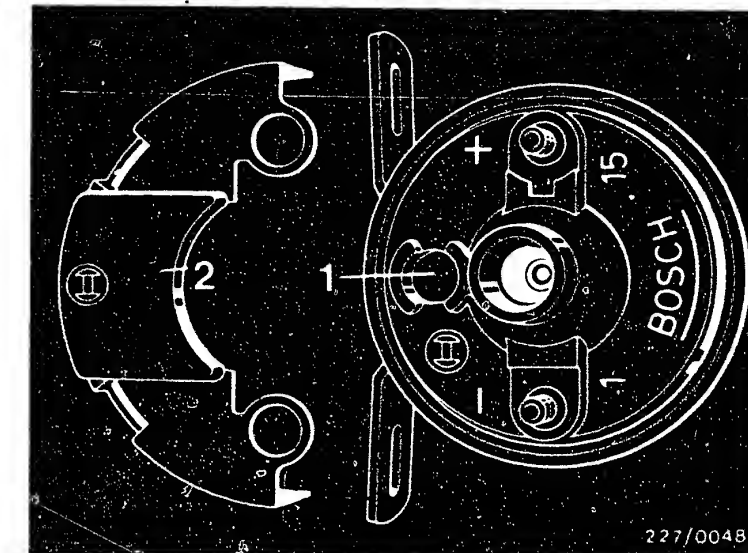
1 = Plug

2 = Protective cap

1. If plug is not in position and/or sealing compound has escaped, replace trigger box and ignition coil.

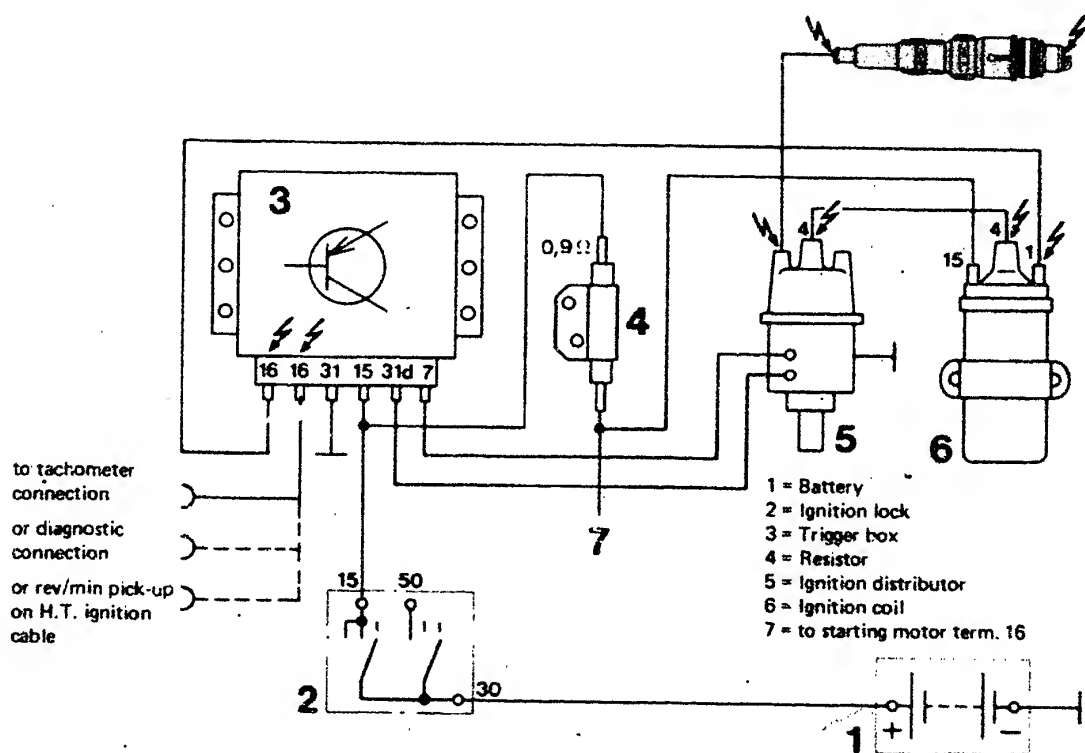
Terminal diagram

Below is a typical terminal diagram of a semi-conductor ignition system, the danger points are marked with red high-voltage arrows. We would point out that all semi-conductor ignition systems, even the older ones, are to be regarded as dangerous in the sense as defined by this bulletin.

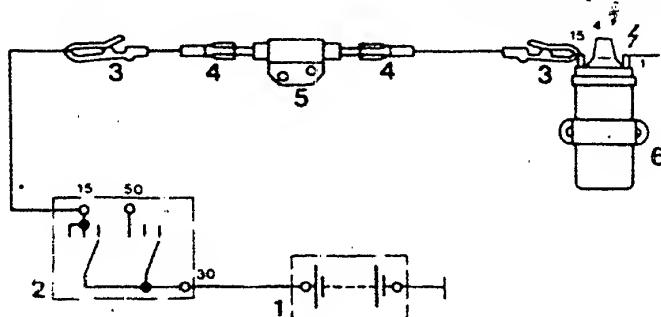
1 = Battery

4 = Blade receptacle

Connect a ballast resistor of 0.9 or 1.0 Ohm (see Fig.) in series in the line to term. 15 of the ignition coil (take care not to cause a short circuit). After the rotational-speed measurement, the ballast resistor must be removed (otherwise starting difficulties and misfiring). Connect tester as per operating instructions.
